GARDNER ROOF COATINGS

THE EXPERTS IN SUSTAINABLE ROOFING SOLUTIONS

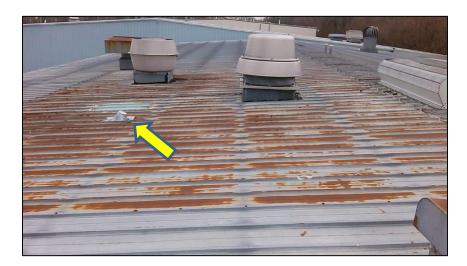
Rusted panels on roof section B. All unnecessary penetrations should be removed.

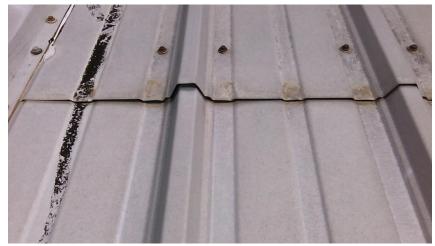
Horizontal seams lifted allowing moisture infiltration. All Horizontal seams will be taped and coated with Elastomeric compound before two coats of Elastomeric roof coating is applied.

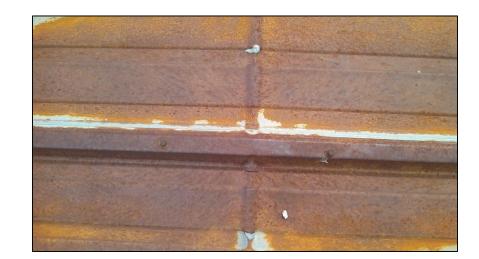
Heavily rusted panels and fasteners. These areas would be cleaned before applying Elastomeric coating.

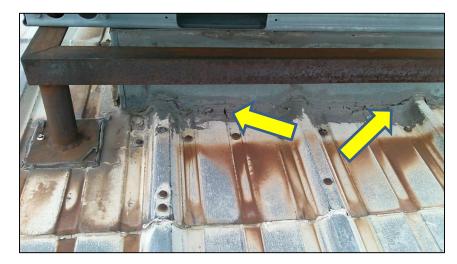
Plastic roofing cement should not be used on a metal roof system due to expansion and contraction of the panels resulting in holes and cracks.

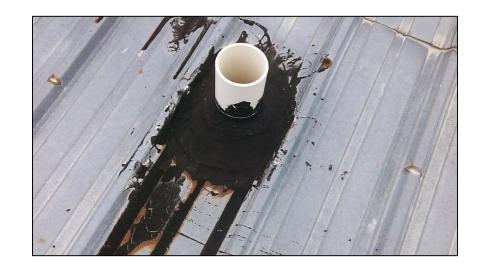
Plastic roof cement around soil stack flashing. Roofing tar to be scraped off and a new flashing installed.

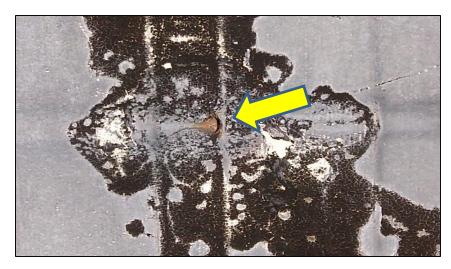
Hole at ridge. This is a leak area.

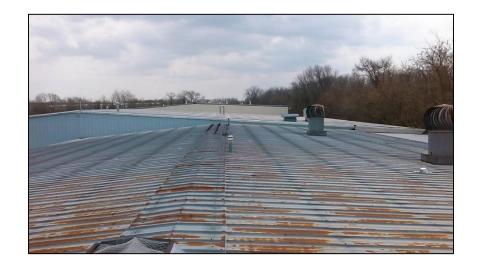
View looking East over rusted panels.

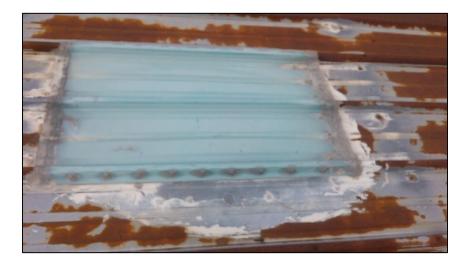
Patch needs to be properly sealed and coated.

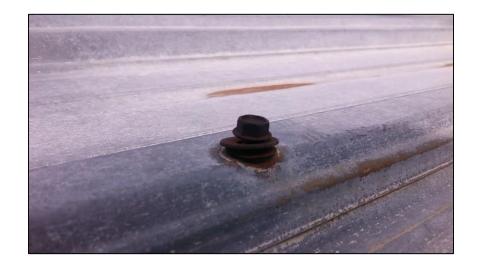
One of many fasteners backed out. These areas are prone to leak.

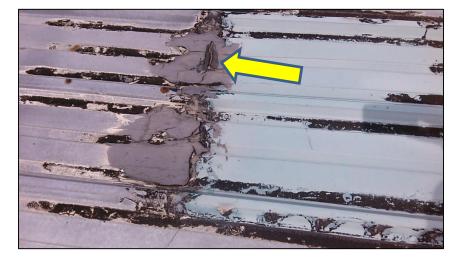
Horizontal seam patched using roofing cement. Due to expansion and contraction roofing cement does not hold up and cracks form.

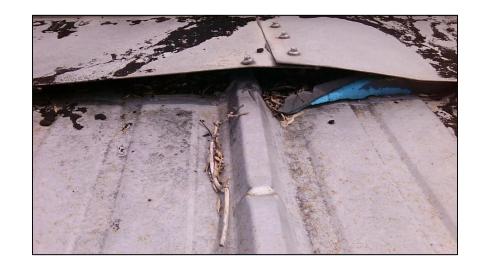
Lifted flashing with debris between the two sections of roof B. This entire area would be screwed down and sealed before Elastomeric coating is applied.

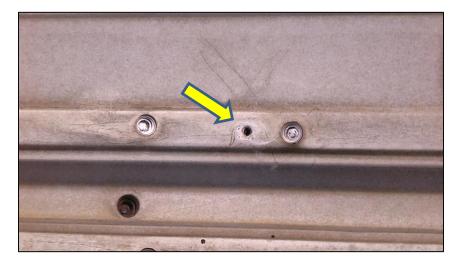
Missing fasteners on roof A. This is a leak area.

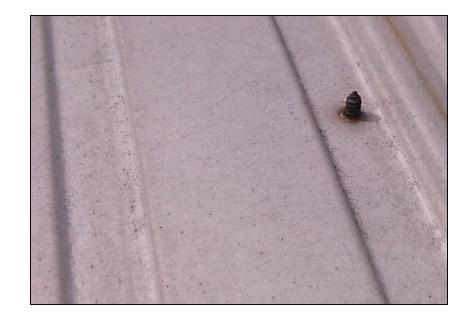
Screw from below coming up through roof panel.

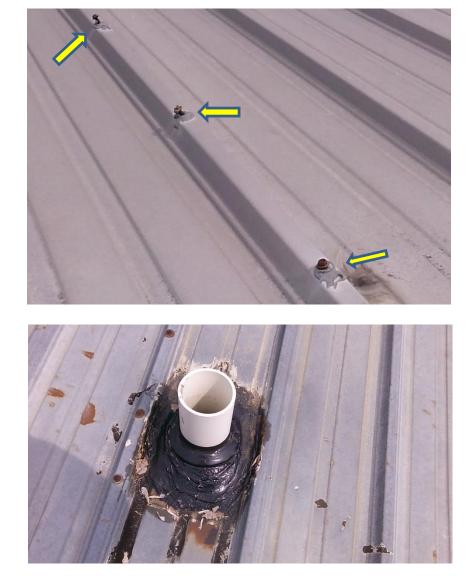
Fasteners coming loose on roof D. All roof surfaces will be pressure washed and all fasteners tightened before any Elastomeric coating is applied.
